NASA-DoD Lead-Free Electronics Project

2010 Aircraft Airworthiness and Sustainment (AA&S) Conference

May 13, 2010

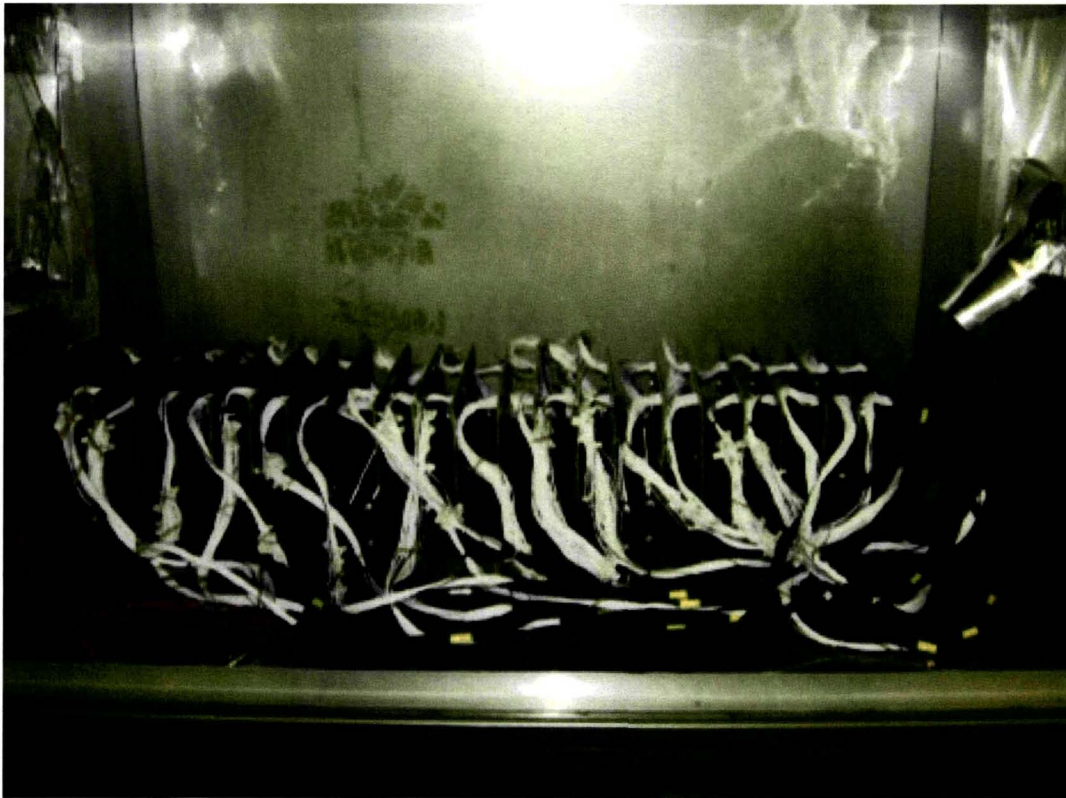
Thermal Cycle Testing (-20/+80°C)

- 5 to 10°C/minute ramp
- 30 minute dwell at 80°C
- 10 minute dwell at -20°C

**~ 3,000 Thermal Cycles
Completed**

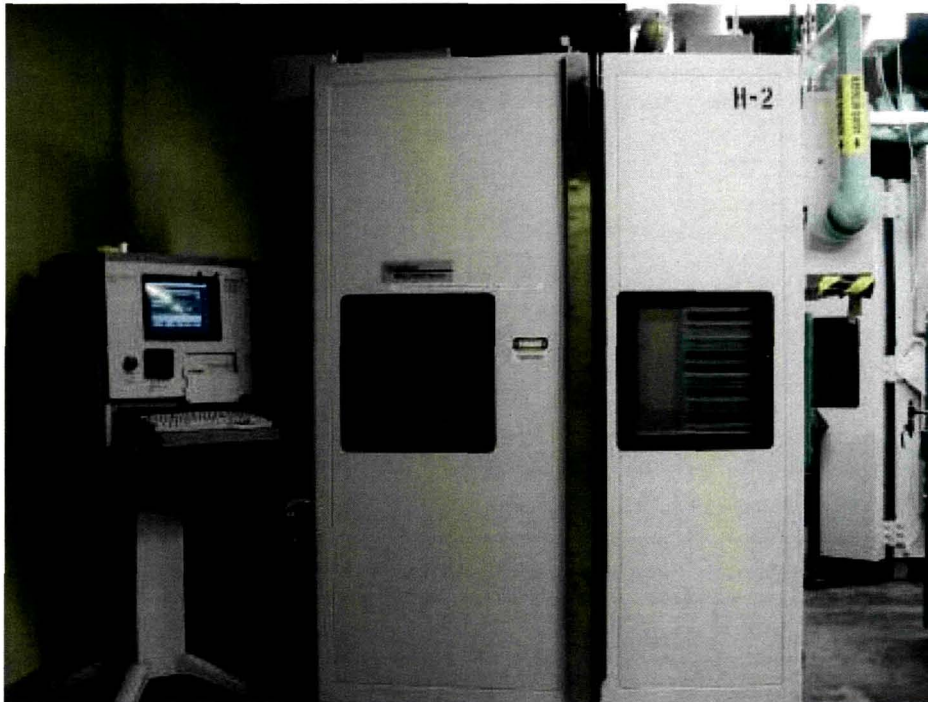
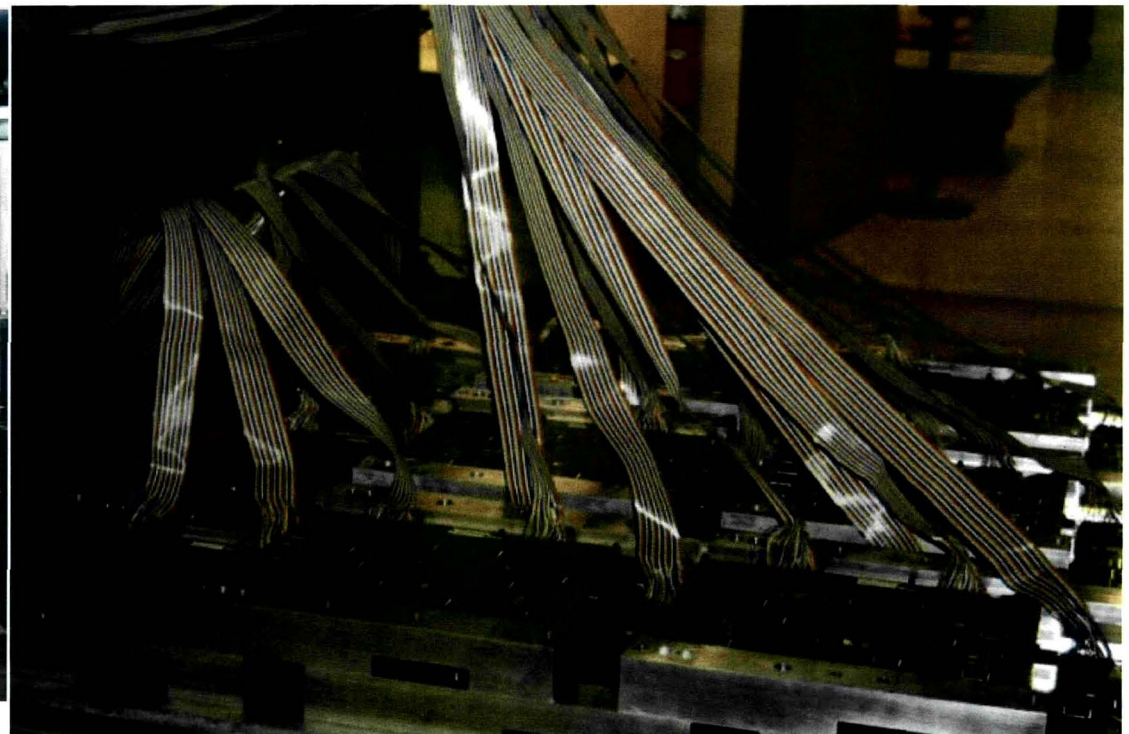
Thermal Cycle with Vibration

- -55°C to +125°C
- 20°C/minute ramp
- 15 minute dwell at -55°C and +125°C
- Vibration for the duration of the thermal cycle
- 10 g_{rms} pseudo-random vibration initially
- Increase vibration level 5 g_{rms} after every 50 cycles
- 55 g_{rms} maximum

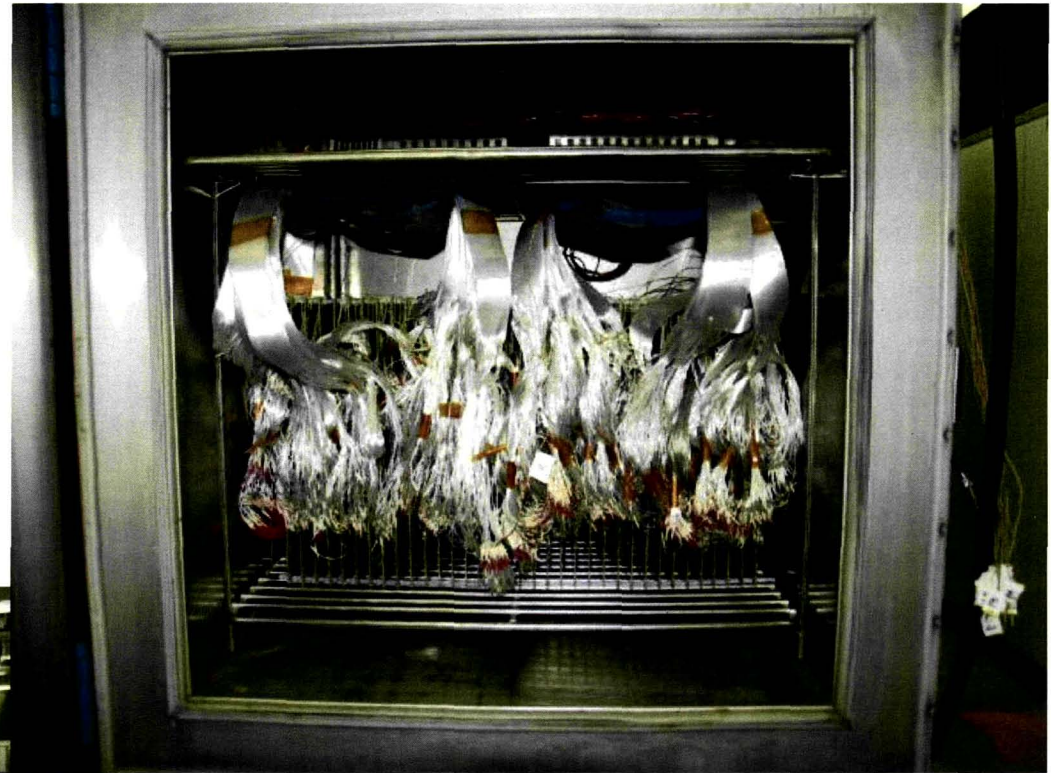
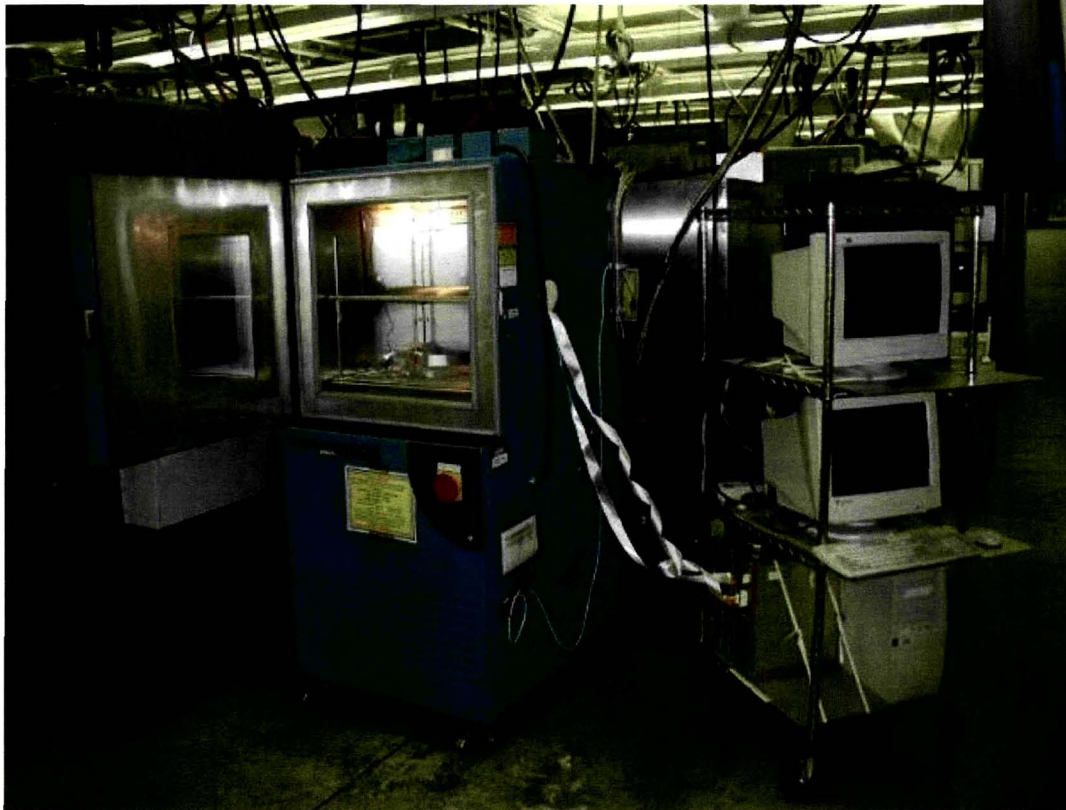
Thermal Cycle Testing (-55/+125°C) *Rockwell Collins*

- 5 to 10°C/minute ramp
- 30 minute dwell at 125°C
- 10 minute dwell at -55°C

**~3,000 Thermal Cycles
Completed**

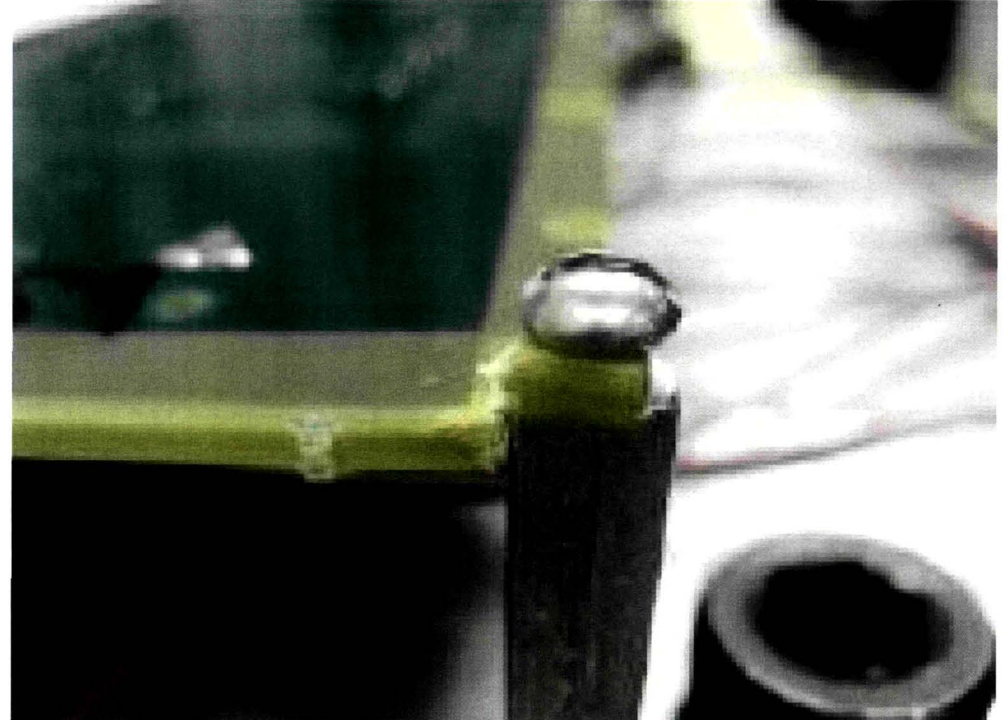
Drop Testing

- Only component to have significant failures – BGA 225
- Most failures occurred on or near the corners.
- General ranking – Based on Raw Data – No Failure Analysis
 - Overall; Manufactured test vehicles performed better than Rework test vehicles
 - SnPb Manufactured performed better than Lead-Free Manufactured
 - SnPb Reworked performed better than Lead-Free Reworked
